APPENDIX D

Photographs of the Lower Feather River Corridor Study Area

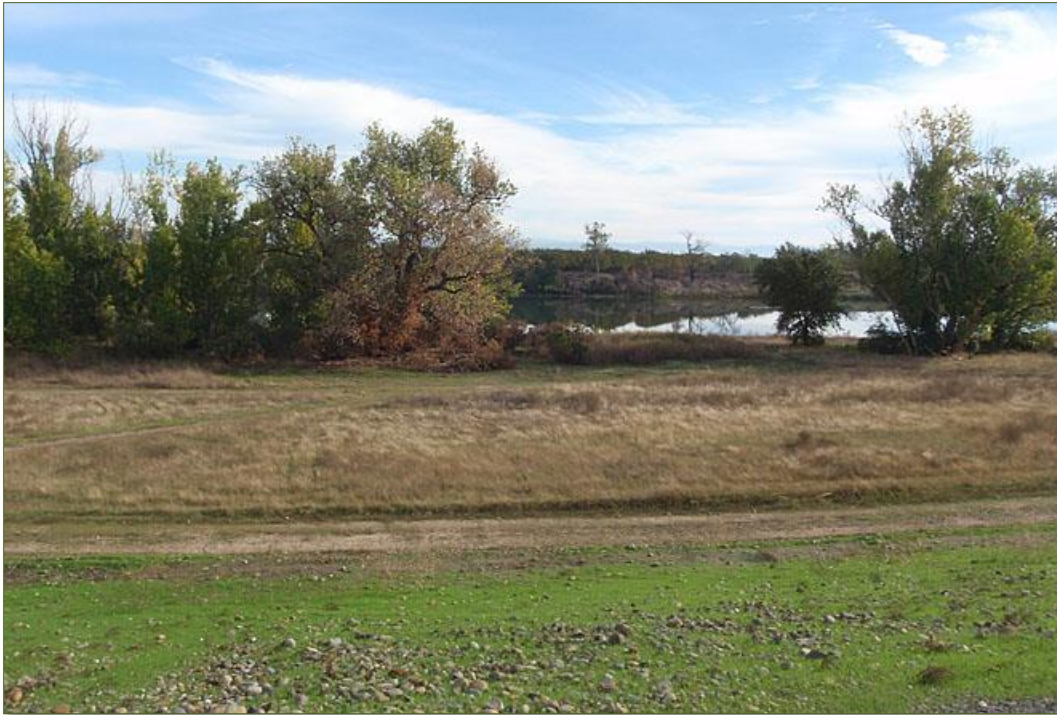
Annual grassland (n=0.030) and open riparian forest (n=0.050).

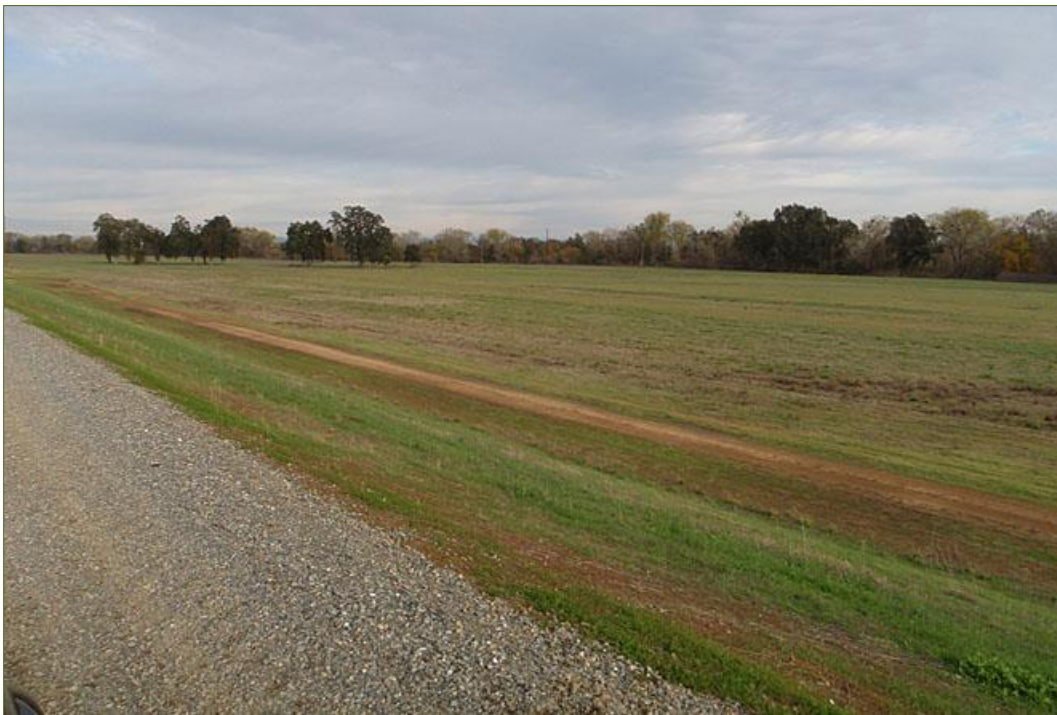
Native perennial grassland and valley oak savanna (n=0.030) in the Bear River setback restoration area.

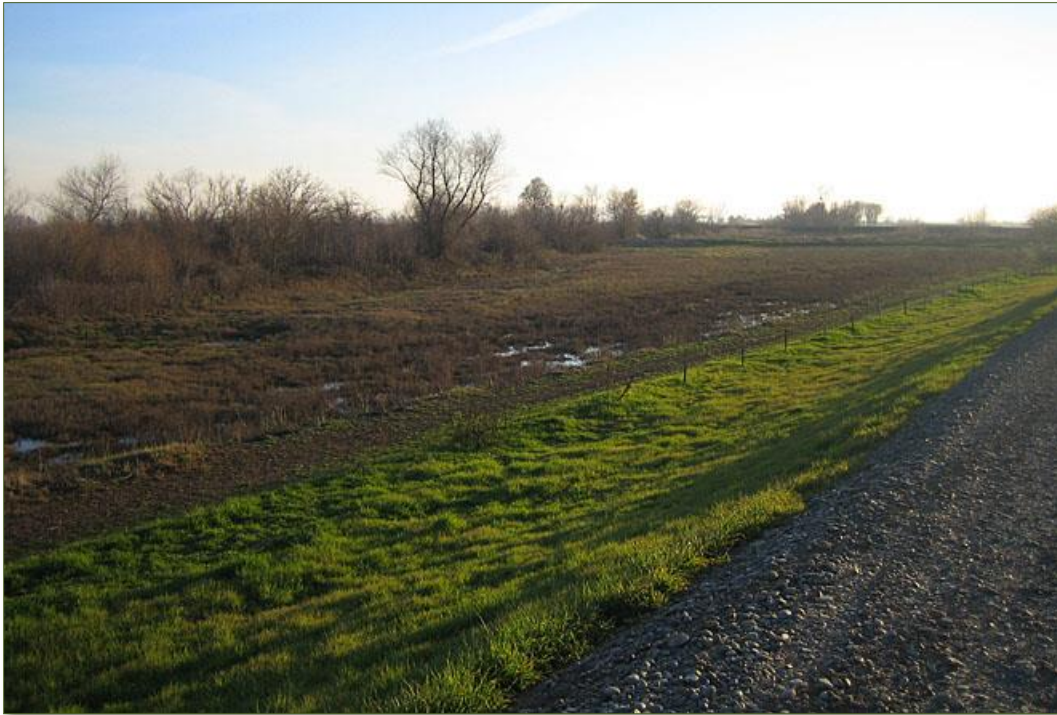
Seasonal wetlands (n=0.030).

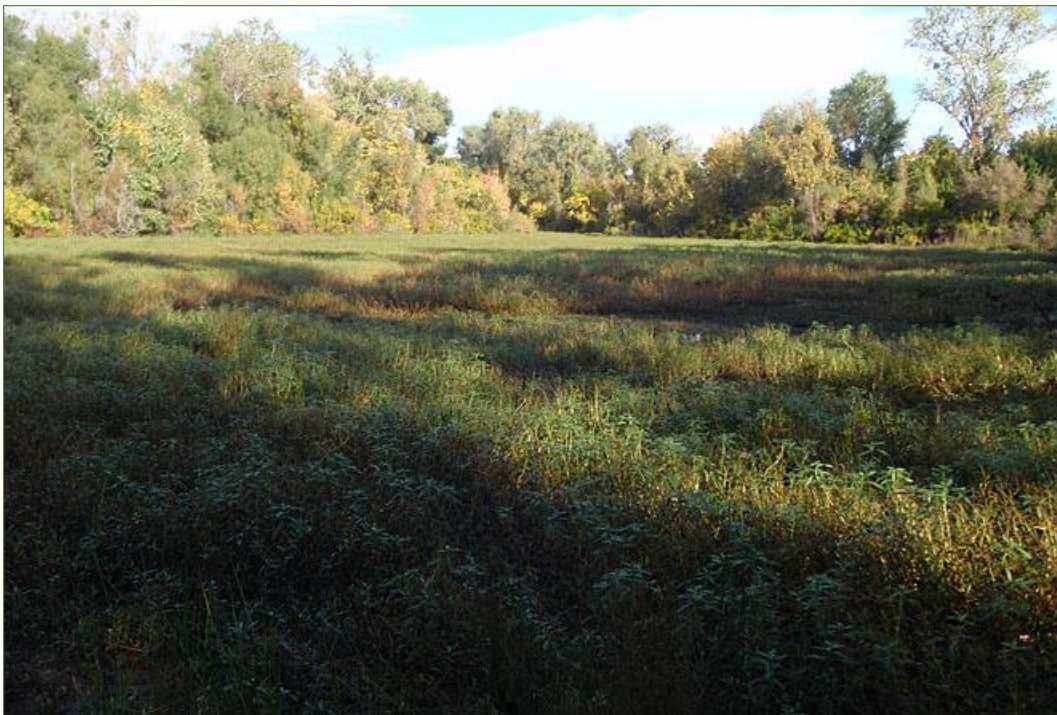
Low herbaceous marsh (n=0.030) in the Leahn Joshua Halprin Lagoon north of Shanghai Bend and dense riparian forest in background (n=0.080).

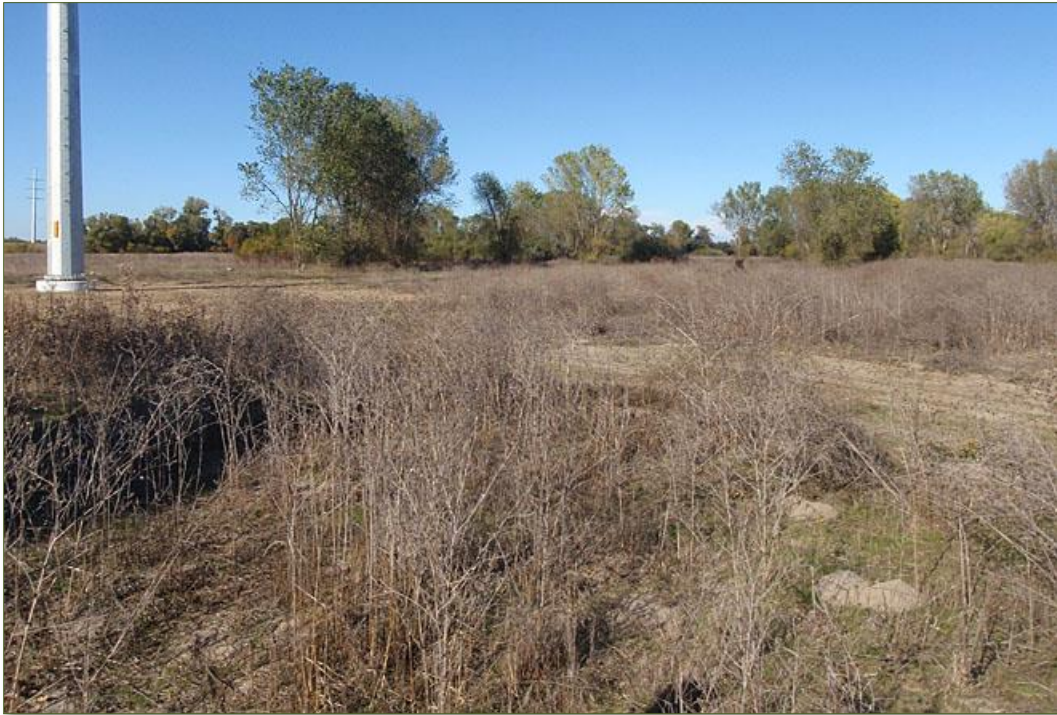
Ruderal vegetation (n=0.030).

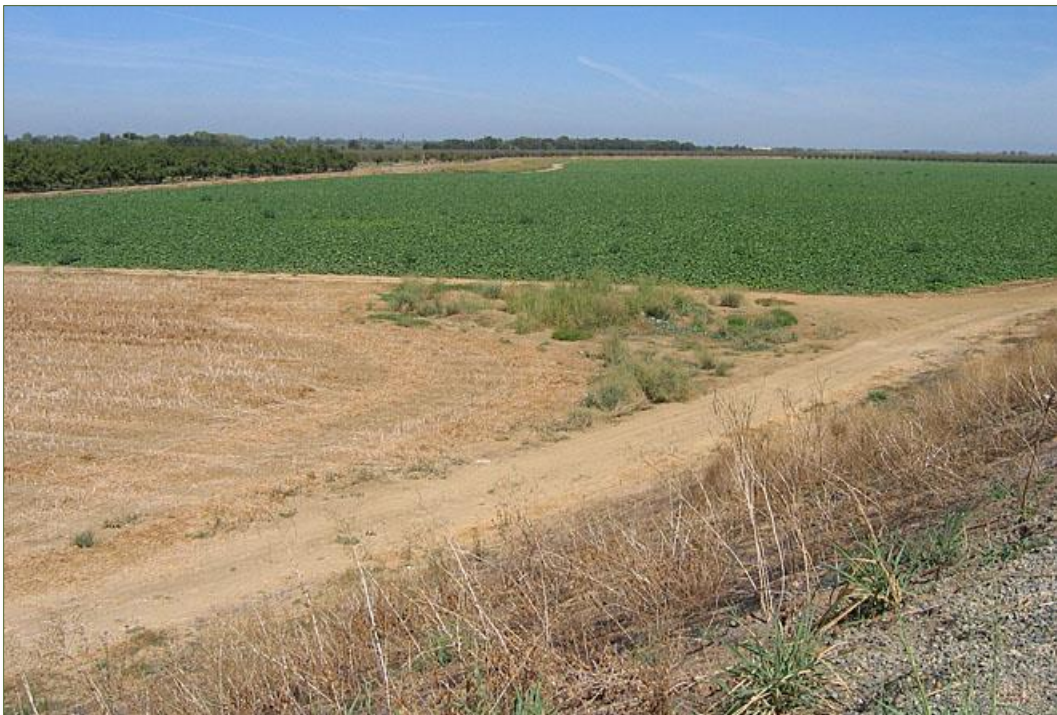
Row crops and fallow field (n=0.030) south of the Bear River on the northeast side of Sheiber Ranch.

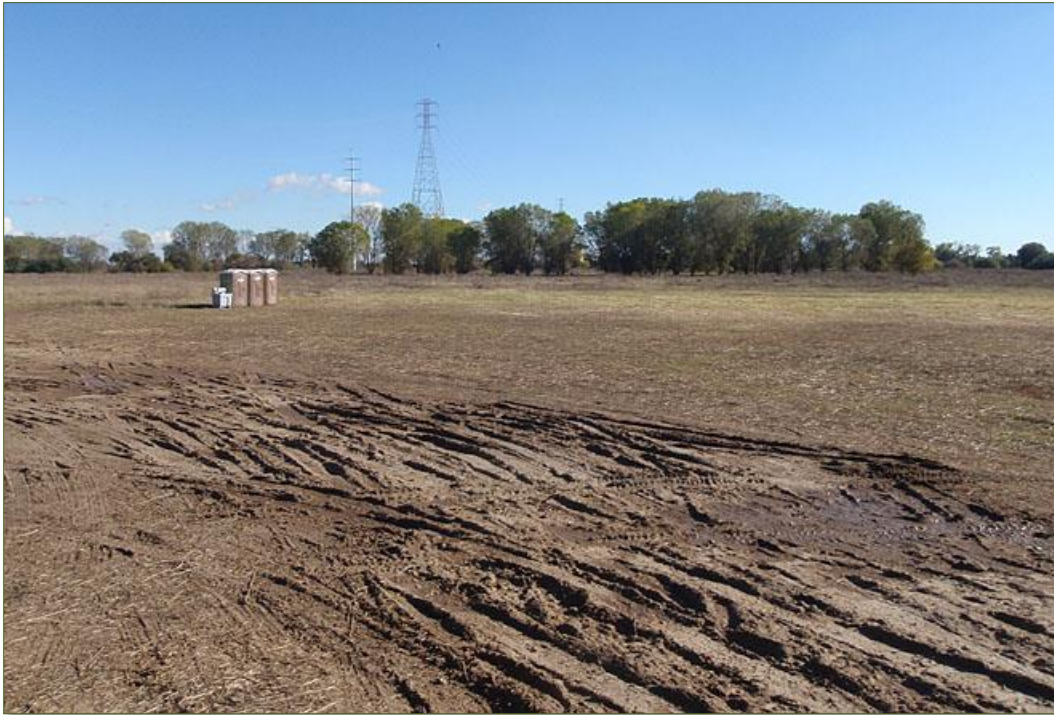
Barren area ($n=0.030$) recently graded in the Feather River levee setback area; open riparian forest ($n=0.050$) in background.

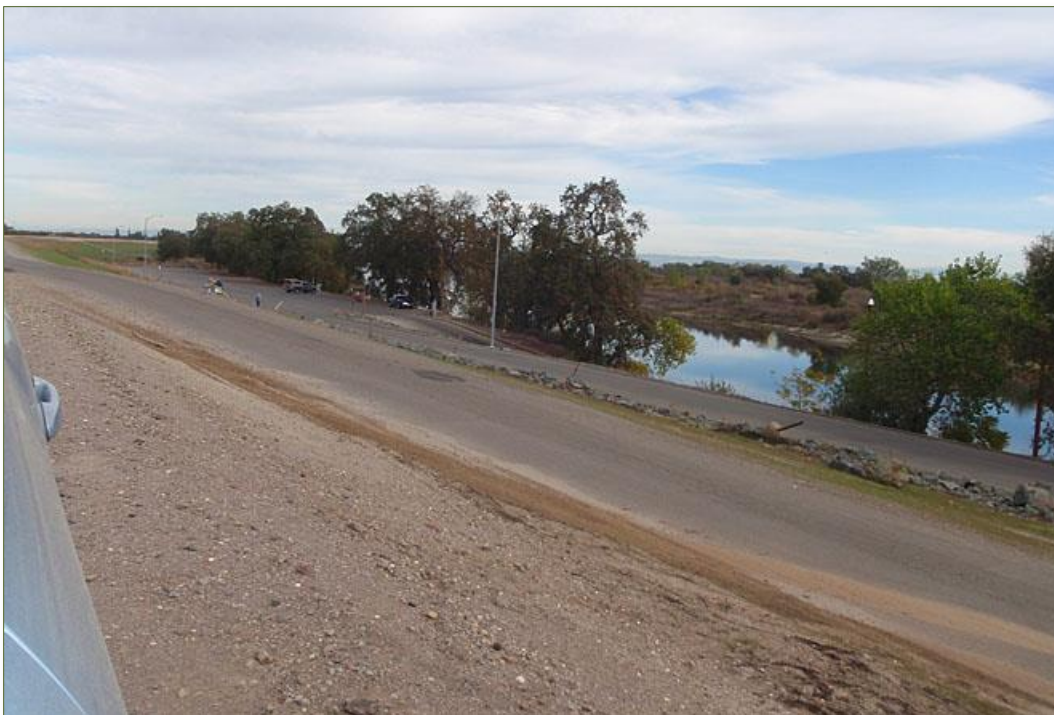
Developed area ($n=0.030$) at the Star Bend Fishing Access and Boat Ramp.

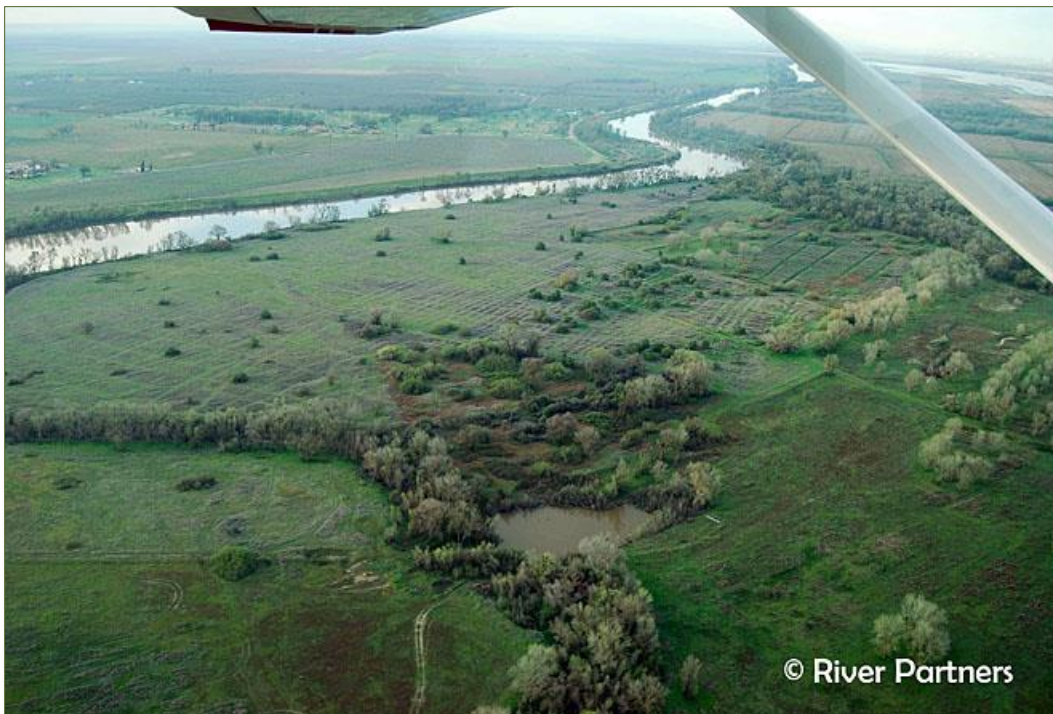
Pond/open water ($n=0.030$) on the river floodplain at Nelson Slough Unit of FRWA (lower center of photograph). Willow scrub ($n=0.065$) surrounds pond, and upland scrub ($n=0.055$) beyond on floodplain. View is looking south toward rock weir and Sutter Bypass in distance.

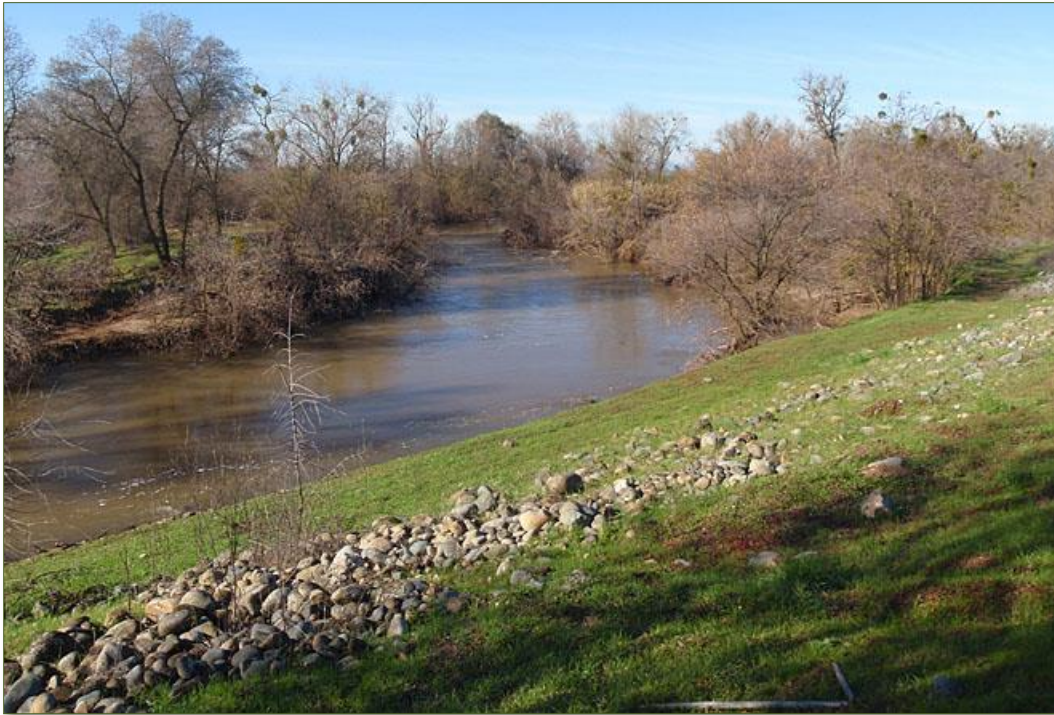
Bear River channel (n=0.030), near the confluence with the Feather River.

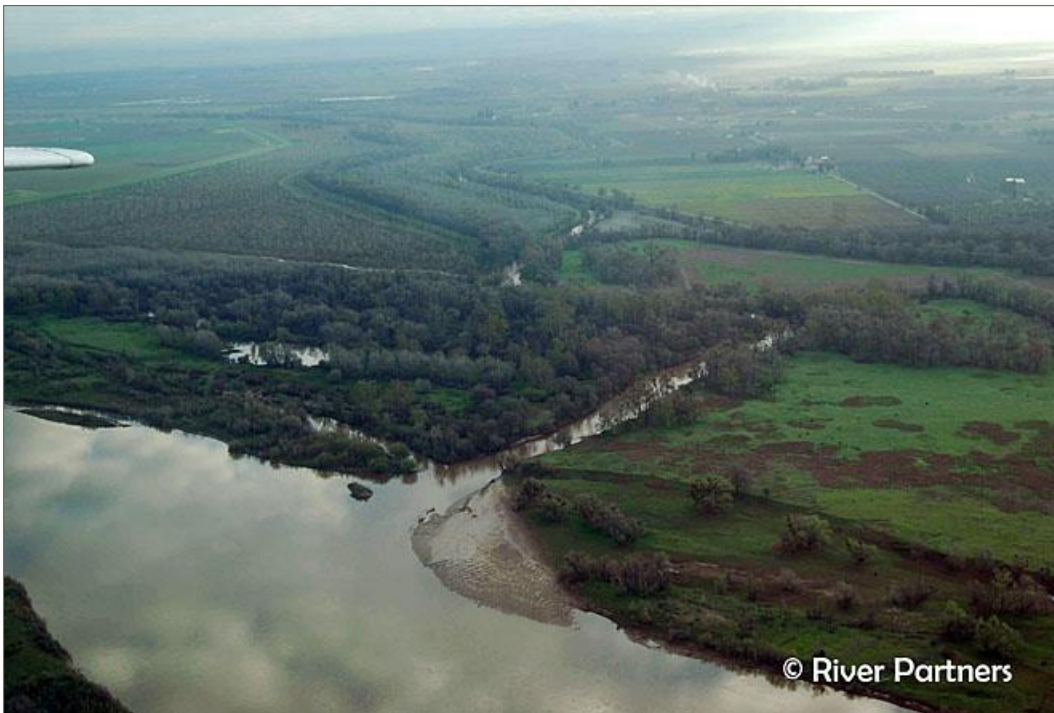
Sandbar (0.035) at the Bear River confluence with the Feather River. View is looking northeast with Bear River setback restoration area in background, and lower Lake of the Woods in left foreground.

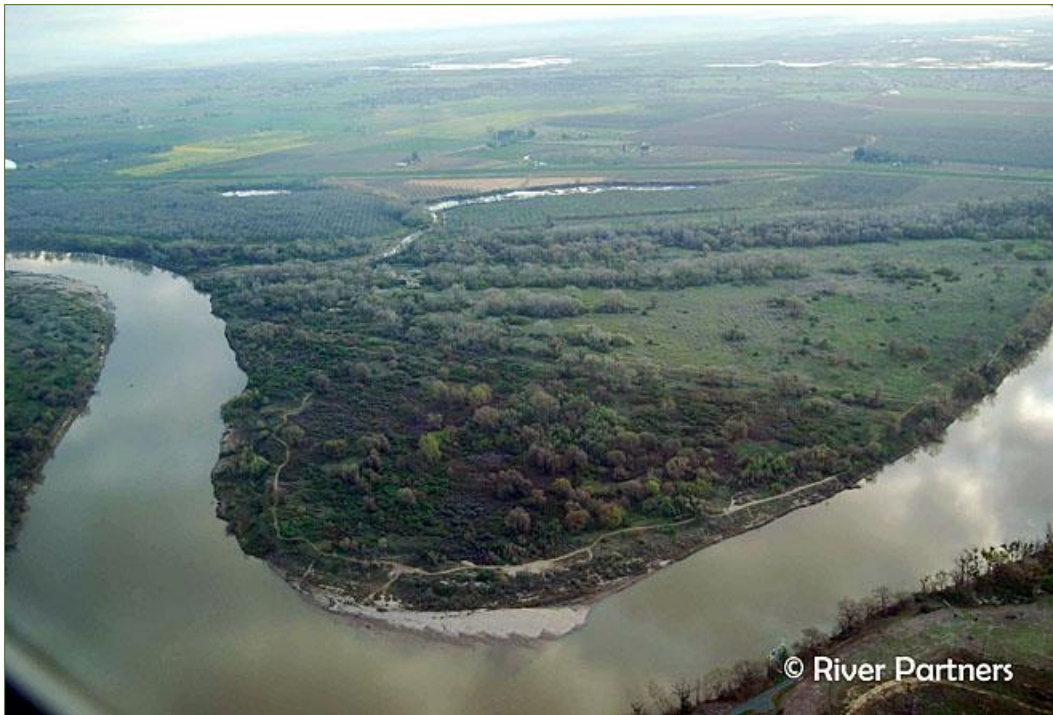
Point bar ($n=0.035$) at Star Bend with Lower Messick Lake drainage swale and walnut orchards in background. View is looking northeast.

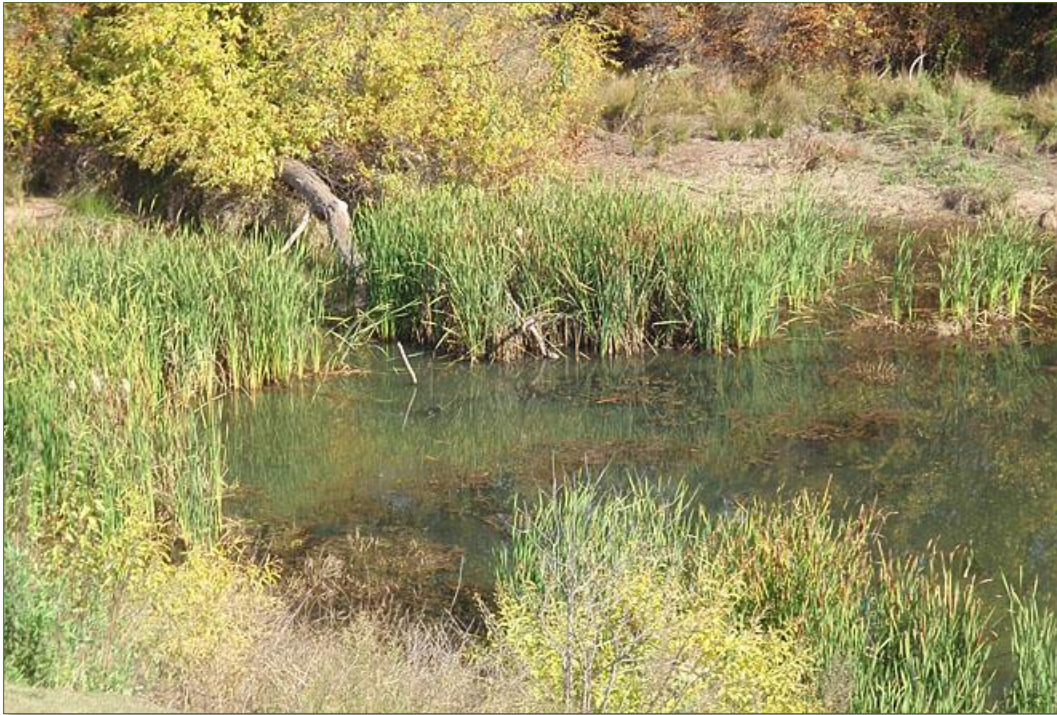
High herbaceous marsh (n=0.035) and open water (n=0.030).

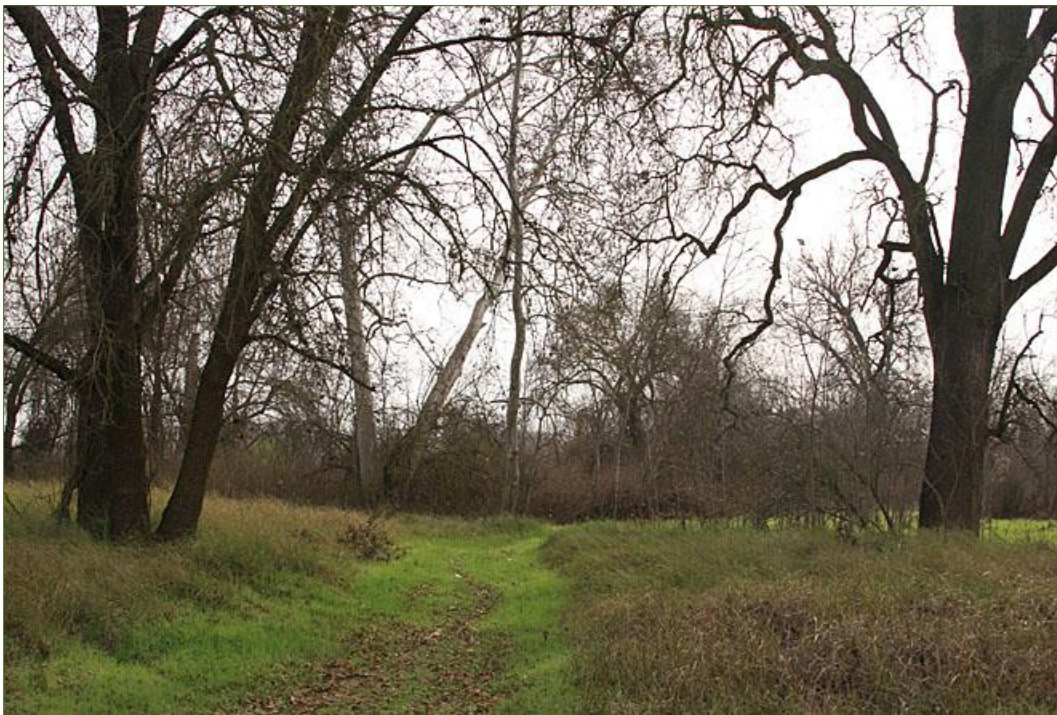
Valley oak woodland (n=0.050). Sycamore (*Platanus racemosa*) trees are left of center.

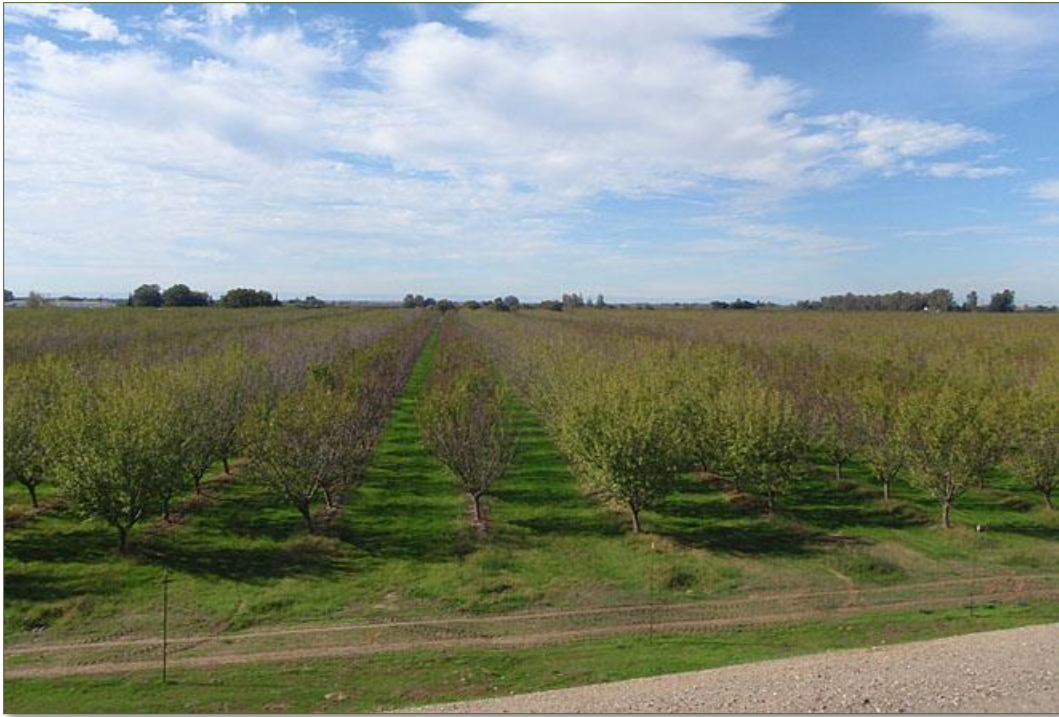
Short tree orchard (n=0.050).

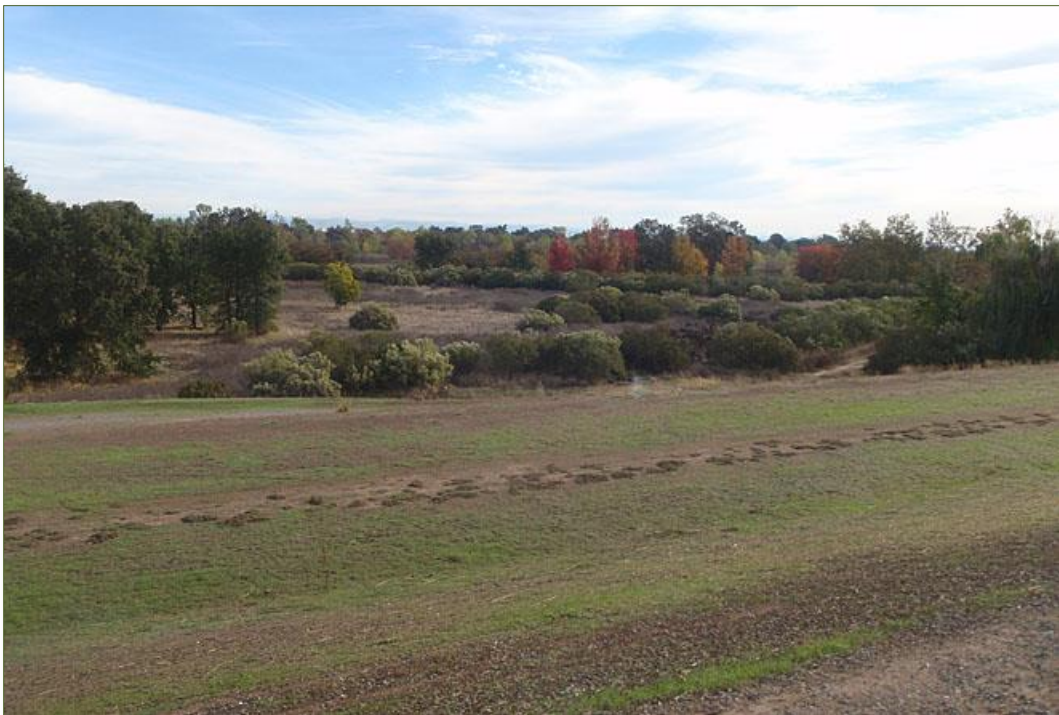
Upland scrub (n=0.055).

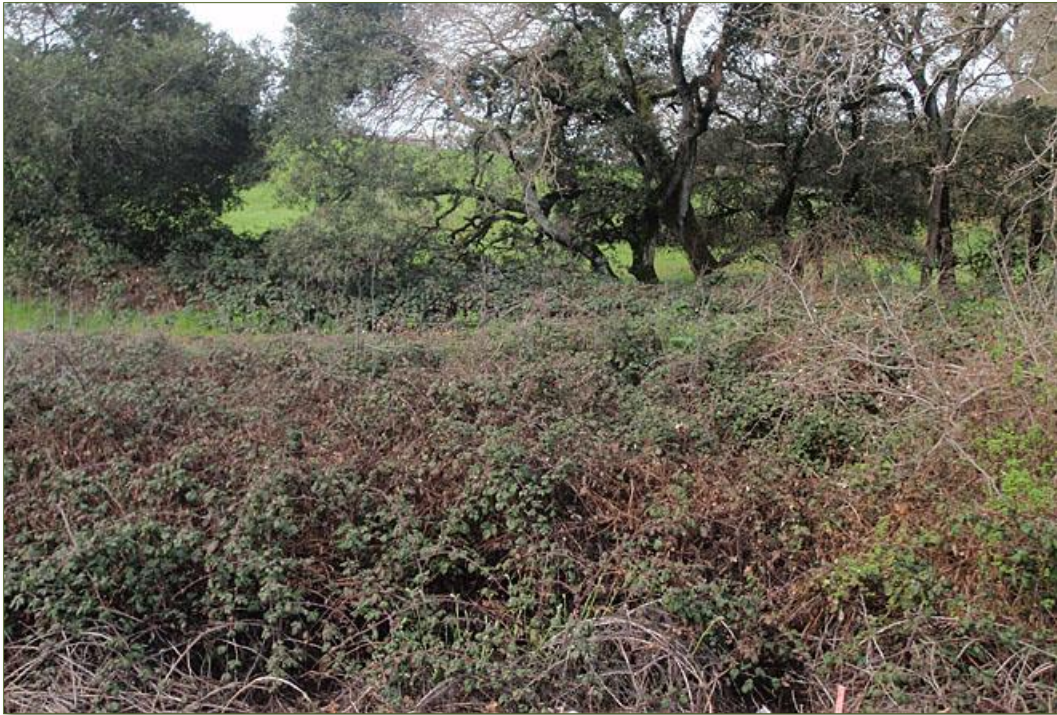
Himalayan blackberry scrub (n=0.055).

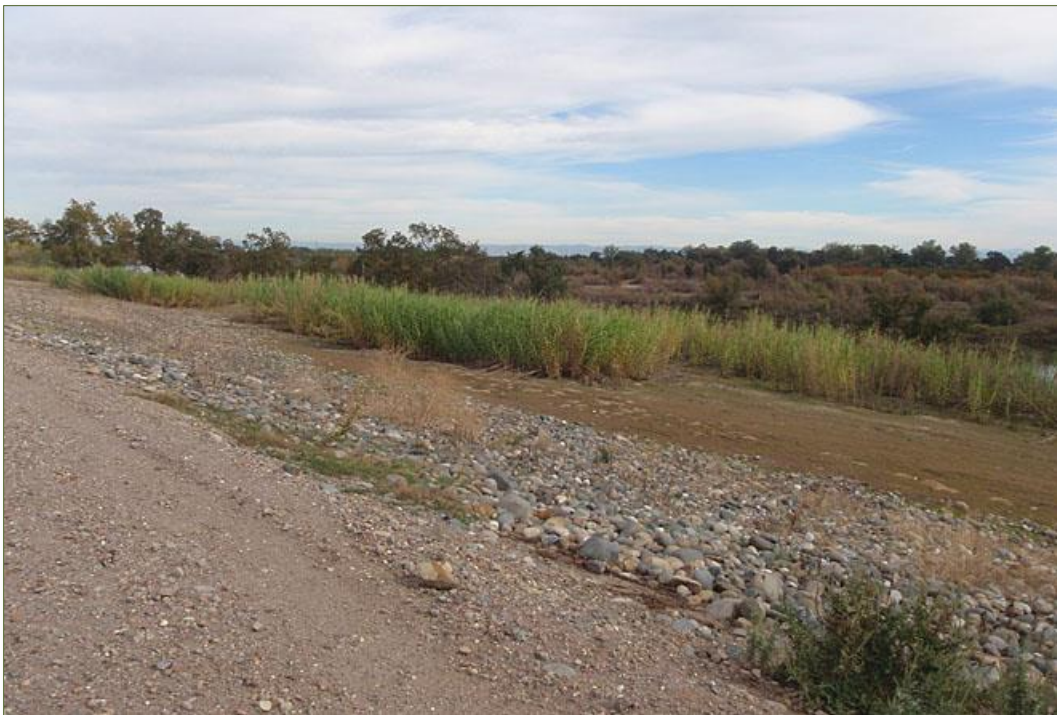
Giant reed (*Arundo donax*) invading the river bank (n-values may vary with flow depth and extent of invasion, from 0.055 to 0.075).

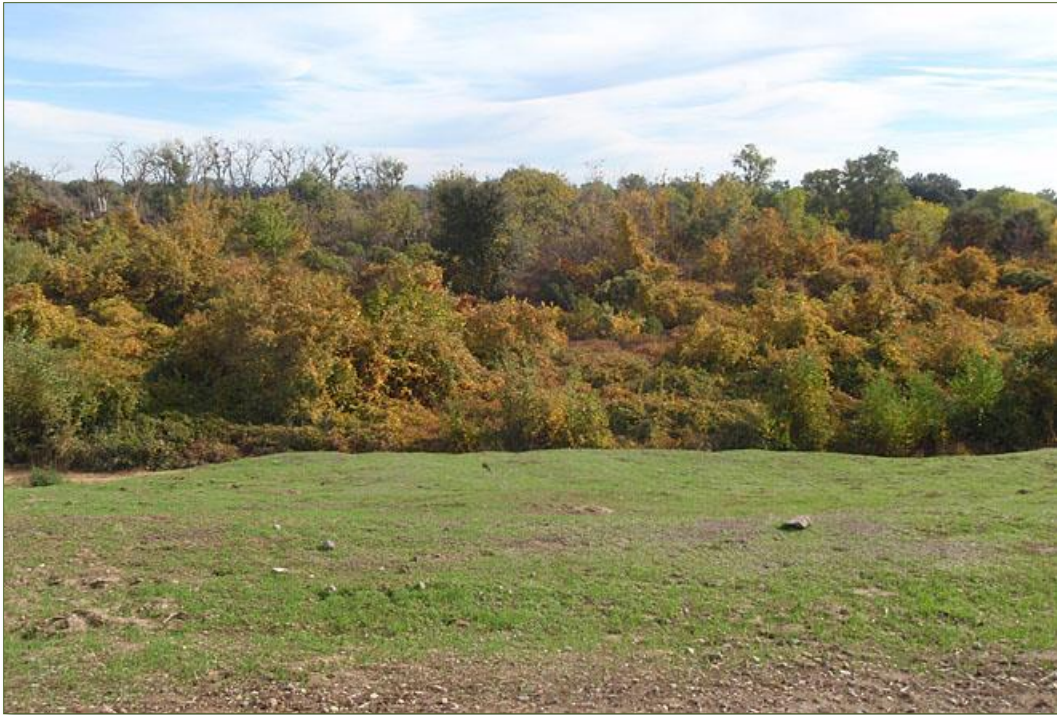
Dense willow scrub ($n=0.065$) in the center of the photograph; dense riparian forest ($n=0.080$) in the background.

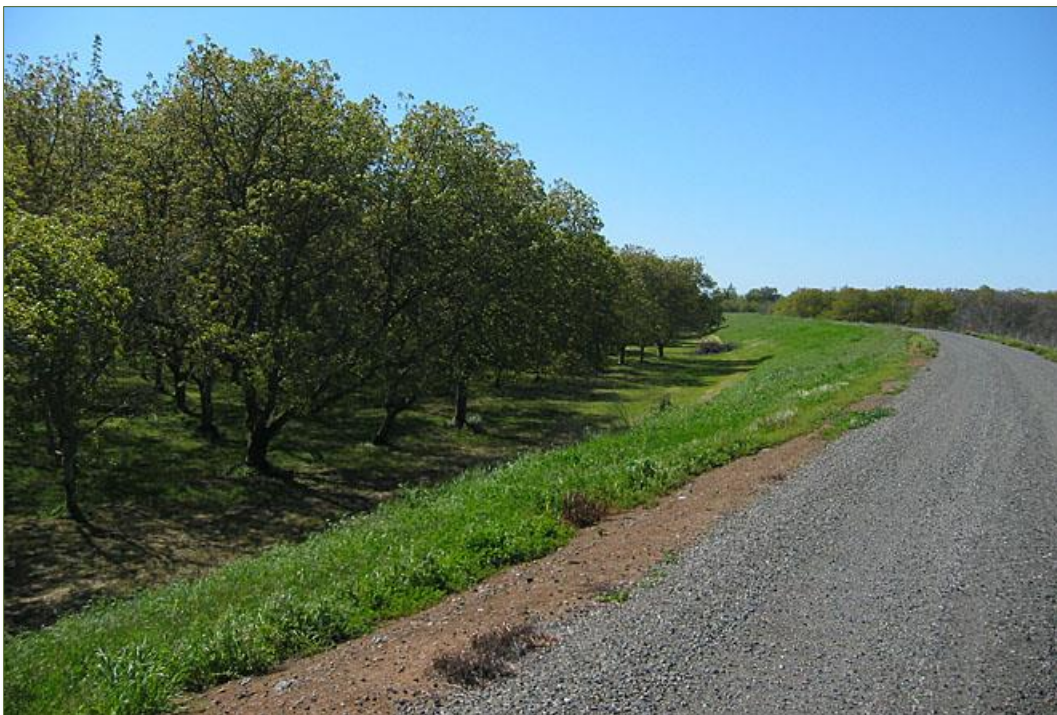
Walnut orchard ($n=0.075$).

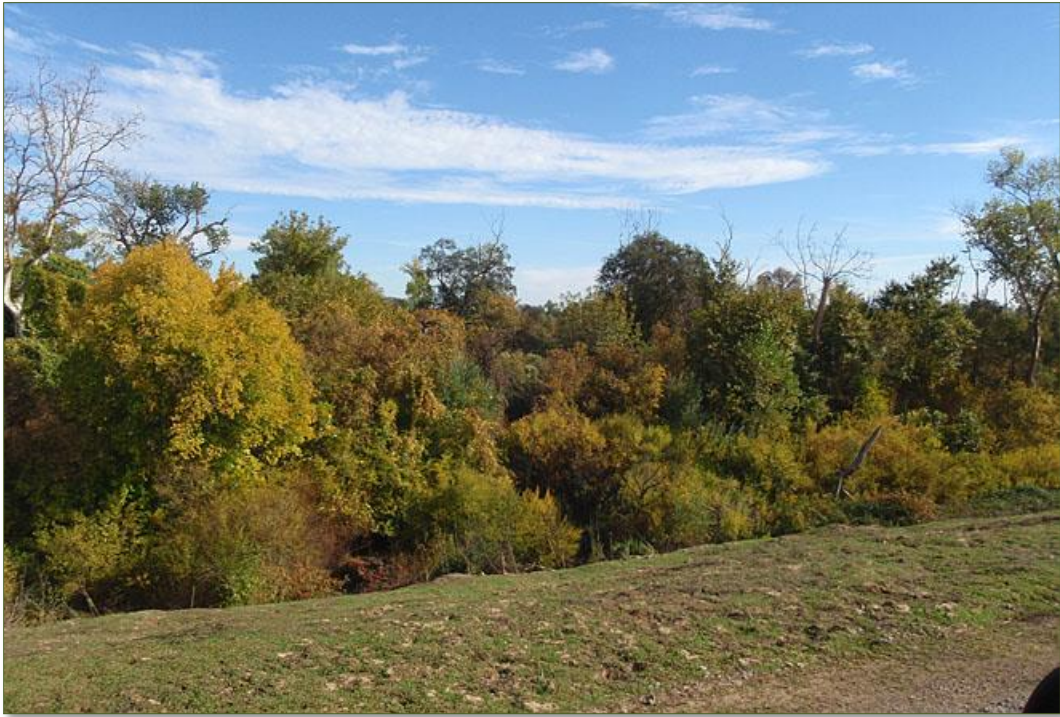
Dense riparian forest (n=0.080).
